# Manhole Inspection Summary

Manhole # S3700\_017MH

**Location** Address: **2417 BRENTWOOD AVE**

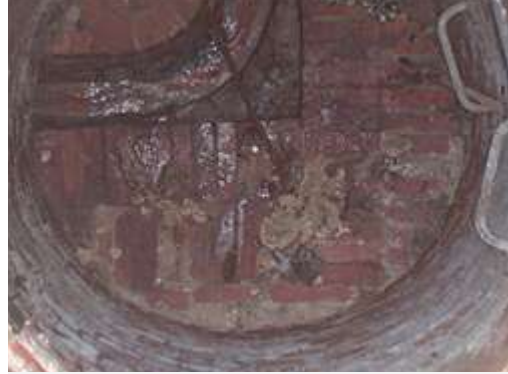
Top View

**Bench** ☒ Exists Material: **Brick** ☐ Parged ☒ **Debris** (not Condition related)

**Surcharge** ☒ **Evidence Of Surcharge** Depth: **1** (ft.) ☐ Active Surcharge Present

Evidence of surcharge - Bench debris.

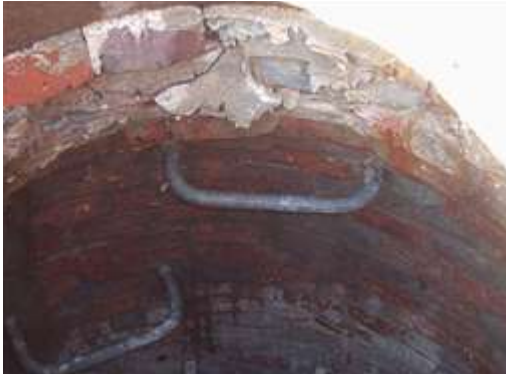
Defect

**Frame** Offset: **0** (in.) Condition: ☐ Sound ☐ Cracked ☒ **Leaks**

Condition: ☐ Sound ☐ Cracked ☐ Root Intrusion ☐ Loose Brick ☒ **Deteriorated**

Infiltration: ☐ None ☒ **Joint** ☐ Cracks ☐ Mortar ☐ Roots ☒ **Wall**

Frame leaks. Adjustment deterioration and infiltration. Corbel and Barrel infiltration - other side.

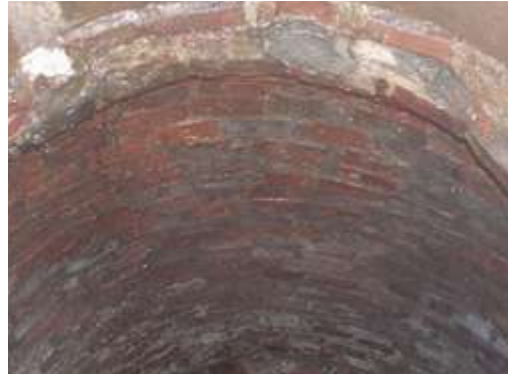
Defect

Frame leaks. Adjustment deterioration and infiltration. Corbel and Barrel infiltration.

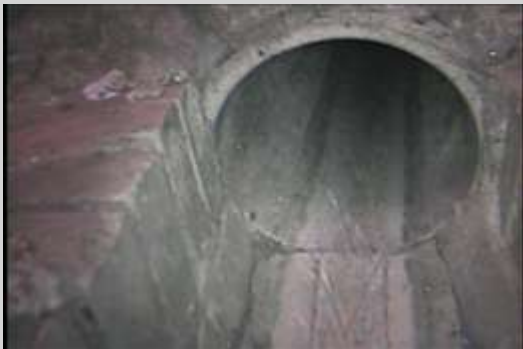
### 8 in. Circular Gravity Sewer Pipe In @ 9 O'Clock

Infiltration: **None** Pipe Seal Cond: **Cracked**
